**DEPARTMENT OF TRANSPORTATION**

Contract #: 04-0120F4Cty: SF/ALA Rte: 80 PM: 13.2/13.9File #: 69.28**WELDING INSPECTION REPORT****Resident Engineer:**Pursell, Gary**Address:** 333 Burma Road**City:** Oakland, CA 94607**Report No:** WIR-009671**Date Inspected:** 20-Aug-2009**Project Name:** SAS Superstructure**OSM Arrival Time:** 700**Prime Contractor:** American Bridge/Fluor Enterprises, a JV**OSM Departure Time:** 1900**Contractor:** Zhenhua Port Machinery Company, Ltd (ZPMC), Changxing Island **Location:** Shanghai, China**CWI Name:** ZPMC and ABF**CWI Present:** Yes No**Inspected CWI report:** Yes No N/A**Rod Oven in Use:** Yes No N/A**Electrode to specification:** Yes No N/A**Weld Procedures Followed:** Yes No N/A**Qualified Welders:** Yes No N/A**Verified Joint Fit-up:** Yes No N/A**Approved Drawings:** Yes No N/A**Approved WPS:** Yes No N/A**Delayed / Cancelled:** Yes No N/A**Bridge No:** 34-0006**Component:** SAS Tower**Summary of Items Observed:**

**Bay #11 East and West Tower Shop**

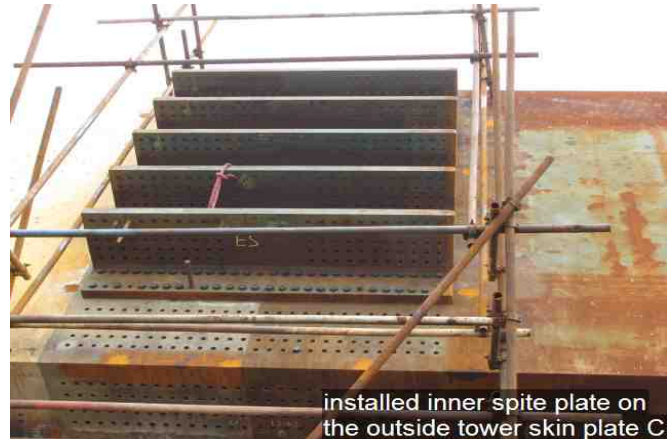
East Tower Lift #1 & #2:- Caltrans QA Inspector observed six ZPMC workers installed two corner spite plates which connect to skin plate B to C and C to D. The alignments of two corner spite plates have been accepted by ZPMC and ABF. Two spite plates will start drilling the hole tomorrow. Caltrans QA Inspector observed four ZPMC workers installed inner spite plate on the outside tower skin plate C. The purpose of installion is for mark up the drill holes location on the spite plate.
